Stryker...

TWO STEPS TO HUB OIL CHECK

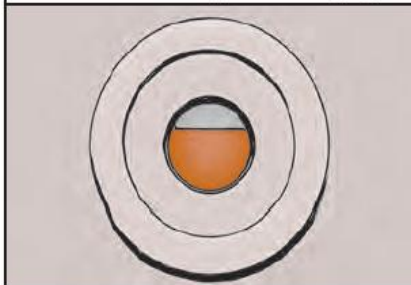
The correct oil level should be in the upper half of the sight glass, usually between $\frac{3}{4}$ and $\frac{7}{8}$ full.

Oil level should be in upper half of sight glass

Wheel hub oil levels should be checked after every operation—but not **immediately** after. You need to allow about an hour for the oil to run back from the planetary gears into the hub to get an accurate reading. Do it too soon and you'll end up overfilling the hubs.

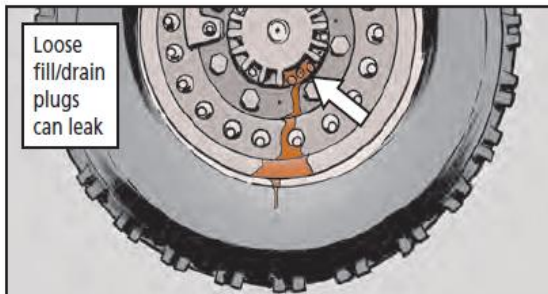
Keep that oil level where it should be by checking the fill and drain plugs periodically. Sometimes those plugs can loosen during operation and allow the hub to leak. If you don't catch it soon enough, the hub can seize up.

Loose
fill/drain
plugs
can leak

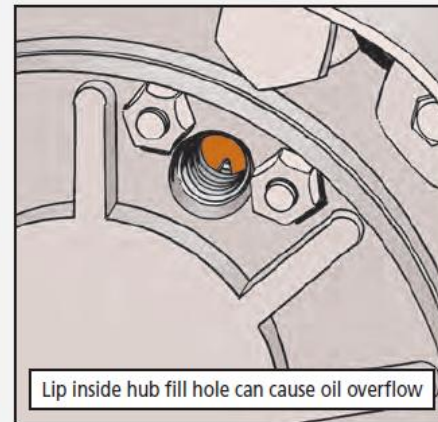
Lip inside hub fill hole can cause oil overflow

Mechanics, make sure you go slow and easy when replacing the oil. There's a small lip inside the filler hole that makes filling the hub slow work. Go too quickly and you'll have a mess to clean up when the oil overflows.
